Centrotest

Centrotest S.r.l. is a company founded in 1987 by Cav. Ivano Emili after 20 years of experience gained in the NDT Division of Thyssen Krupp Acciai Speciali Terni.

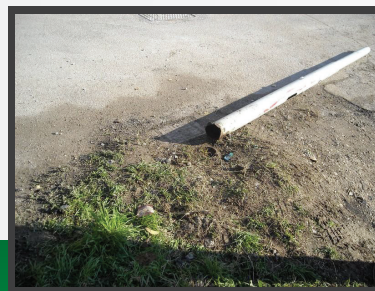
Pole fell in Terzi in 2008 due by corrosion

The collapse of public lighting poles caused by corrosion, is an unusual event but not rare and the consequences can be very serious for the company which takes care of them. In addition to the loss of the pole and the damage caused to the power supply, you can have interruptions of traffic, manufacturing and public utilities, as well as damage to property and people health. There is at least one known recent case in which the collapse of a pole resulted in loss of human life.

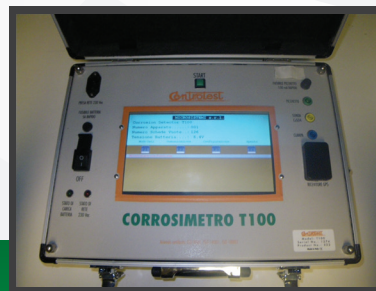
Unit T100 recently patented by Centrotest

By using an advanced technology called L.P. R, CENTROTEST is able to monitor and quantify the residual maturity brackets.

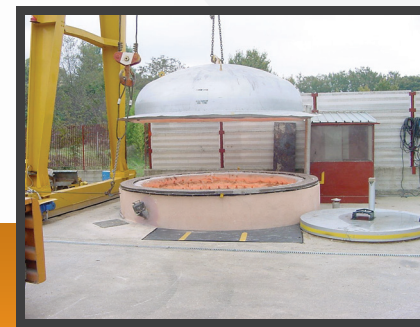
Well furnace

Pit furnace 1: diameter: 3.36 m, height 2.9 metres, maximum temperature: 1200° C

Pit furnace 2: diameter: 1.6, height: 2.75 metres, maximum temperature 1200° C

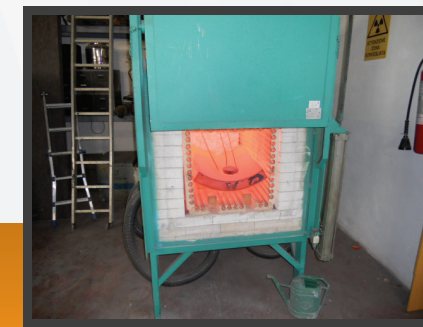
Electric furnace

Electric furnace: 1 meter length, width 0.5 meters, height 0.5 metres maximum temperature 1200° C

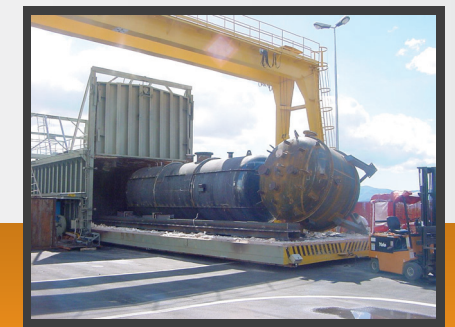
Cooperheat furnace

Cooperheat furnace: length: 24.6 meters, width meters, 3.4 meters height, Max: 980° C
